**Erosion Characteristics and Optical Properties of
State-of-the-Art, Erosion-Resistant Coatings on
Infrared Windows: Boron Phosphide,
Gallium Phosphide, and Zinc Sulfide
on Multispectral Zinc Sulfide**

by
Daniel C. Harris
Research and Technology Division

MAY 1996

NAWCWPNS Technical Publication 8292

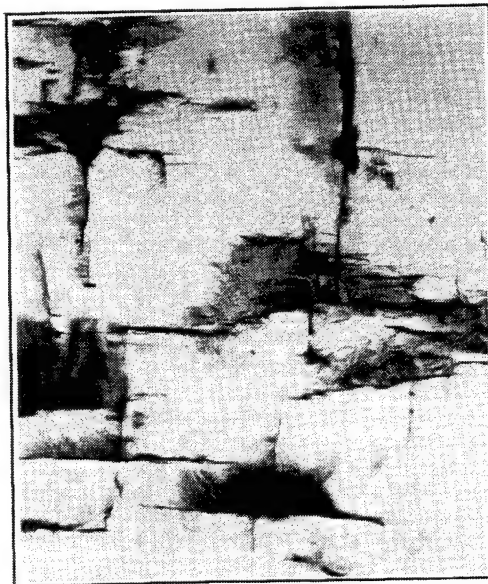
GaP I15D (10 min @ 210 m/s)
 Nomarski micrograph (93×)
 Orthogonal cracking / material loss

GaP I15D (10 min @ 210 m/s)
 Subsurface damage (360×)
 Orthogonal cracking / material loss

GaP I15D (10 min @ 210 m/s)
 Transmission micrograph (59×)
 Subsurface damage

FIGURE 33. Micrographs of Antireflection-Coated Bulk GaP Showing Rain Impact Damage Sites From Whirling Arm Experiments.
